6-cylinder Single Vanos Rattle Procedure

Introduction

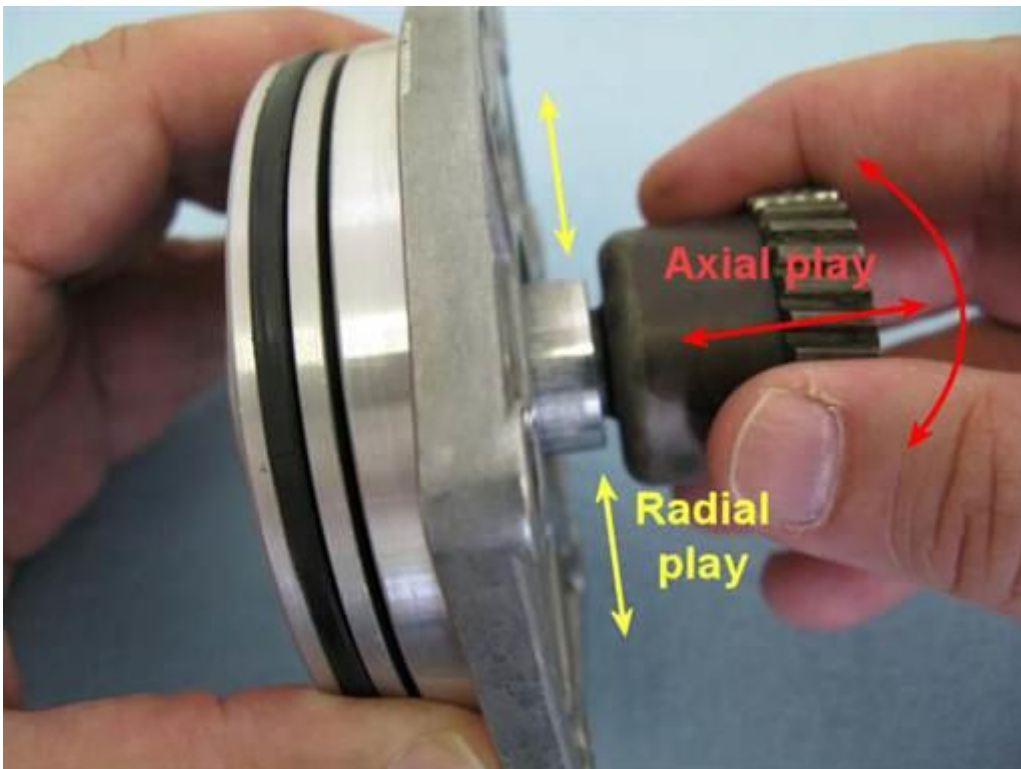
Inspect piston bearing axial play.

Hold piston and tilt (rock) splined shaft to each side to note bearing axial play (free space).

Axial play can also be checked by repeated insertion and withdrawal of splined shaft in/out of piston.

Note: Radial play, side to side movement, is normal and necessary. This should not be confused with axial play, in/out movement.

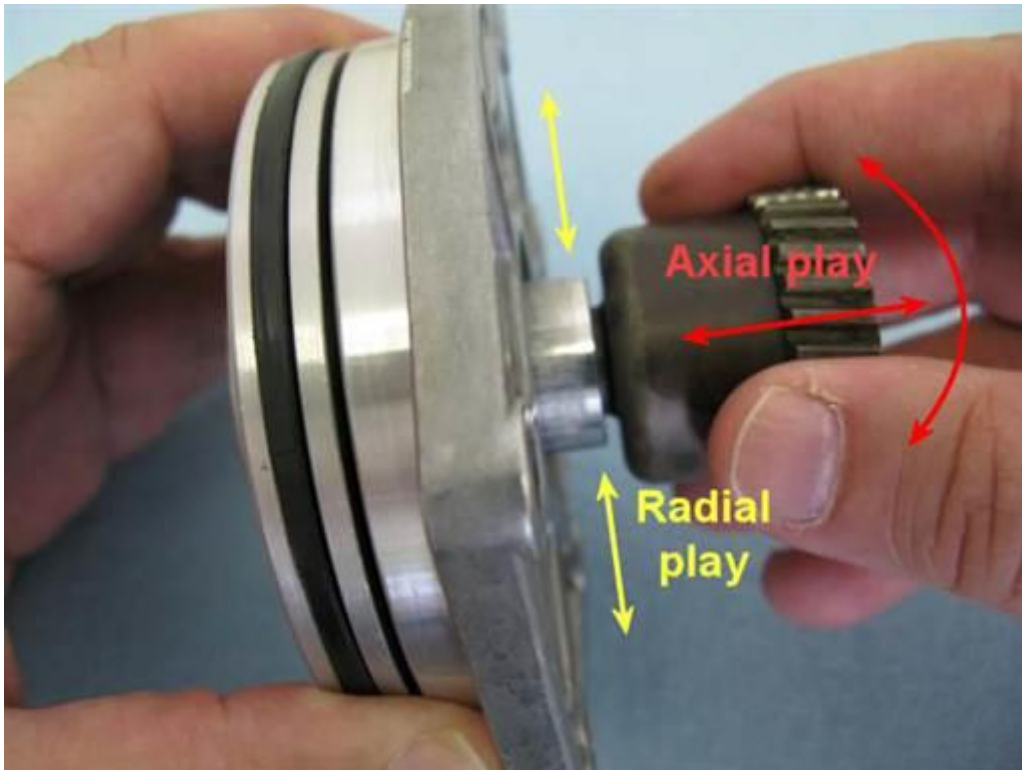
Inspect piston bearing axial play.

Hold piston and rotate splined shaft to note resistance to rotation.

Hold piston and tilt (rock) splined shaft to each side to note bearing axial play (free space).

If splined shaft binds and cannot be rotated then axial fit is too tight and loosening adjustment is needed.

If splined shaft has any tilt movement then axial play is present and tightening adjustment is needed.

Any level of resistance (pre-load) in splined shaft rotation indicates no axial play and is considered an optimal fit.

Note: M3 cars and cars with aftermarket performance cams (Schrick) must have no bearing axial play and bearing should have resistance to rotation (pre-load) to achieve optimal results.

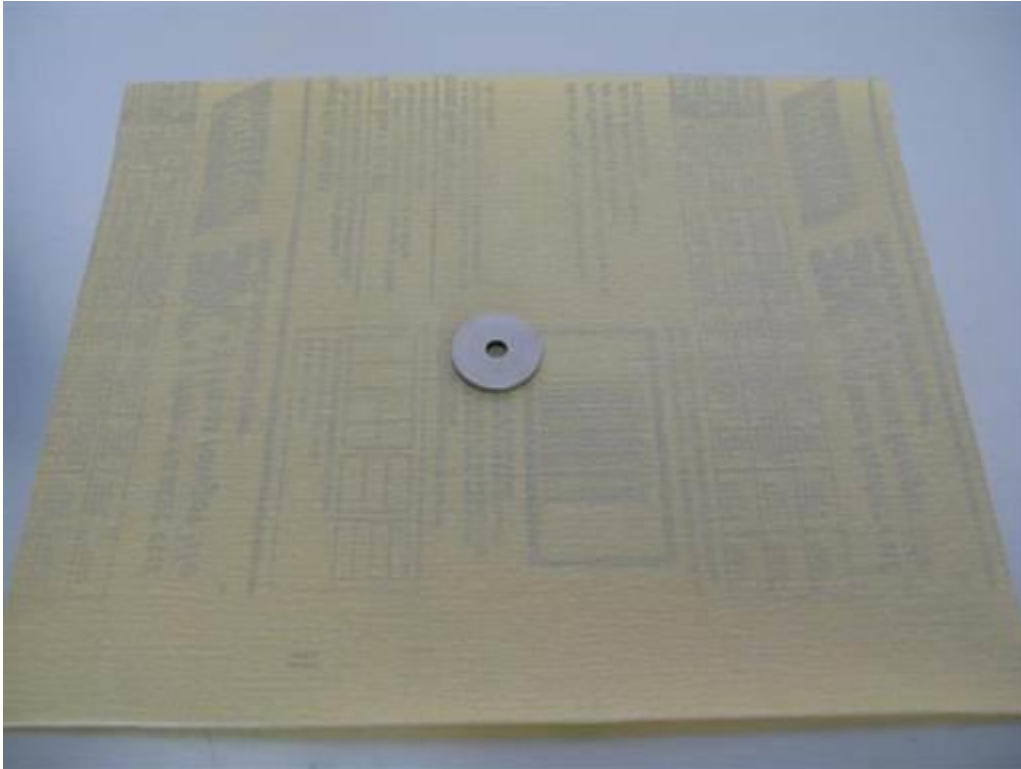
Bearing loosening adjustment.

If splined shaft binds and cannot be rotated then axial fit is too tight and loosening adjustment is needed.

Disassemble piston bearing per above procedure.

Place sandpaper (~400 grade) on flat table top. Place bearing center washer on sandpaper.

Slide washer side to side on sandpaper ~6" back and forth while moderately pressing washer on sandpaper. Perform sanding for 10 seconds.

Rotate washer 90 degrees and repeat sanding process.

Flip washer to opposite side and repeat above sanding procedure; 10 seconds sanding, rotate 90 degrees, 10 seconds sanding.

Clean washer (brake cleaner & towels).

Reassemble piston bearing per above procedure and reassess bearing axial fit.

Note: Washer is made from hardened steel and does not easily wear. Sanding procedure will remove ~.005mm washer height. Washer might need max .015mm height adjustment.

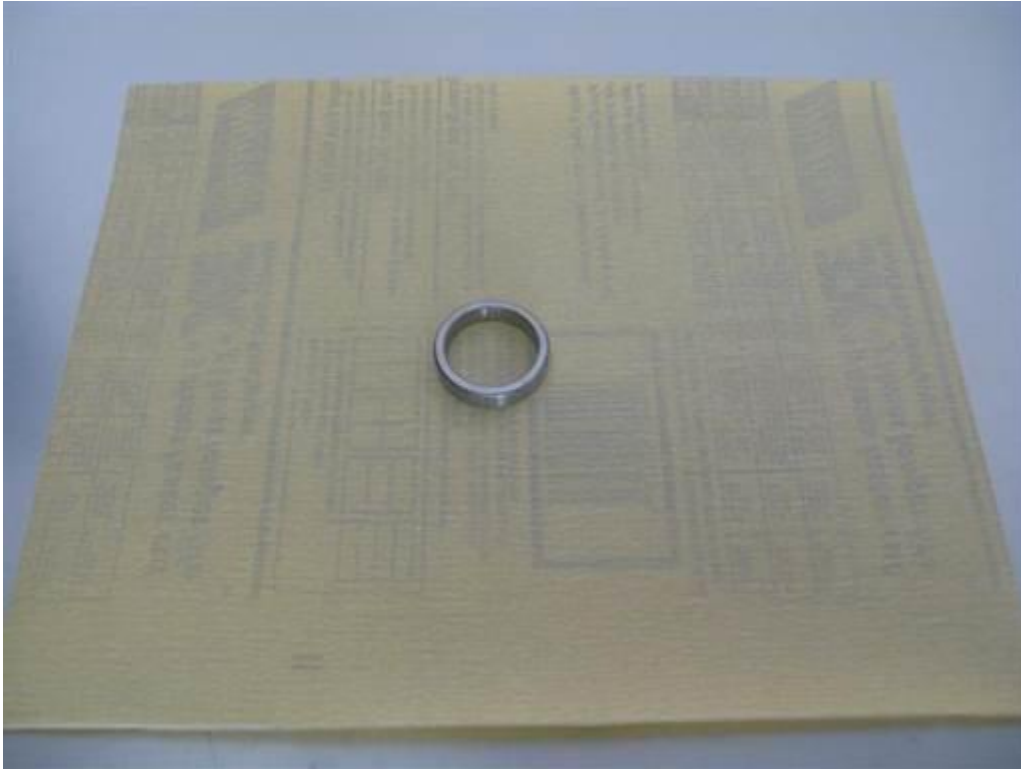
Bearing tightening adjustment.

If splined shaft has any tilt movement then axial play is present and tightening adjustment is needed.

Disassemble piston bearing per above procedure.

Place sandpaper (~400 grade) on flat table top. Place bearing ring on sandpaper.

Slide ring side to side on sandpaper ~6" back and forth while moderately pressing ring on sandpaper. Perform sanding for 10 seconds.

Rotate ring 90 degrees and repeat sanding process.

Clean ring (brake cleaner & towels).

Note: Ring is made from hardened steel and does not easily wear. Sanding procedure will remove ~.005mm ring height. Ring might need max .015mm height adjustment.
