6-cylinder Single Vanos Rattle Procedure

Introduction

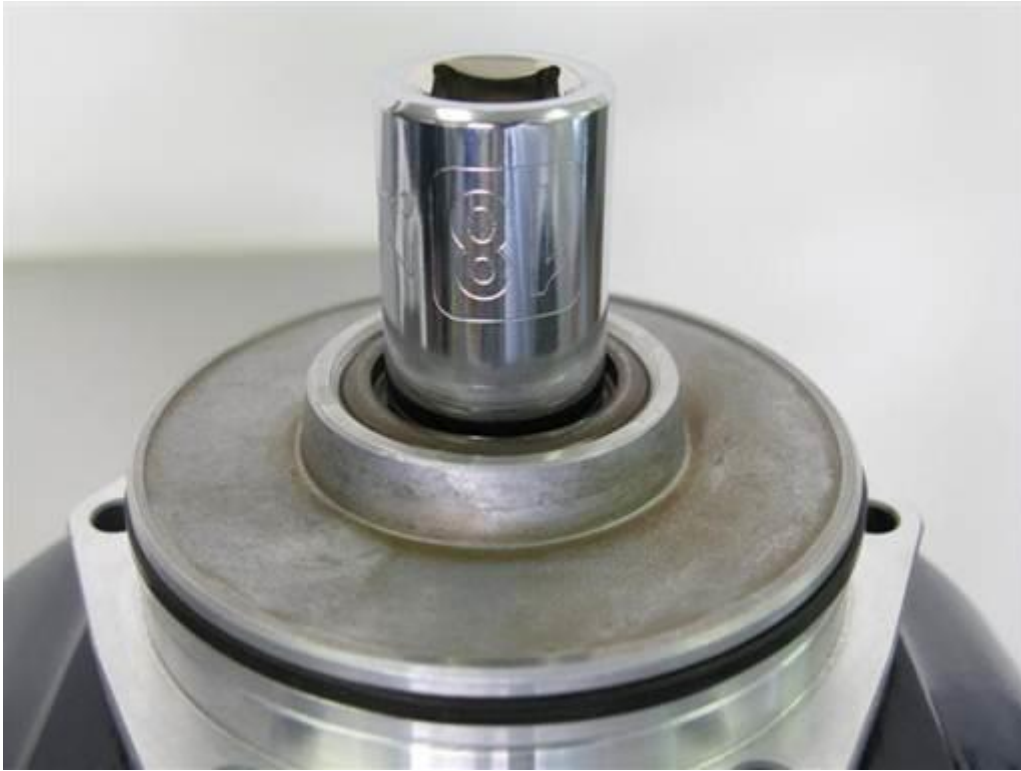
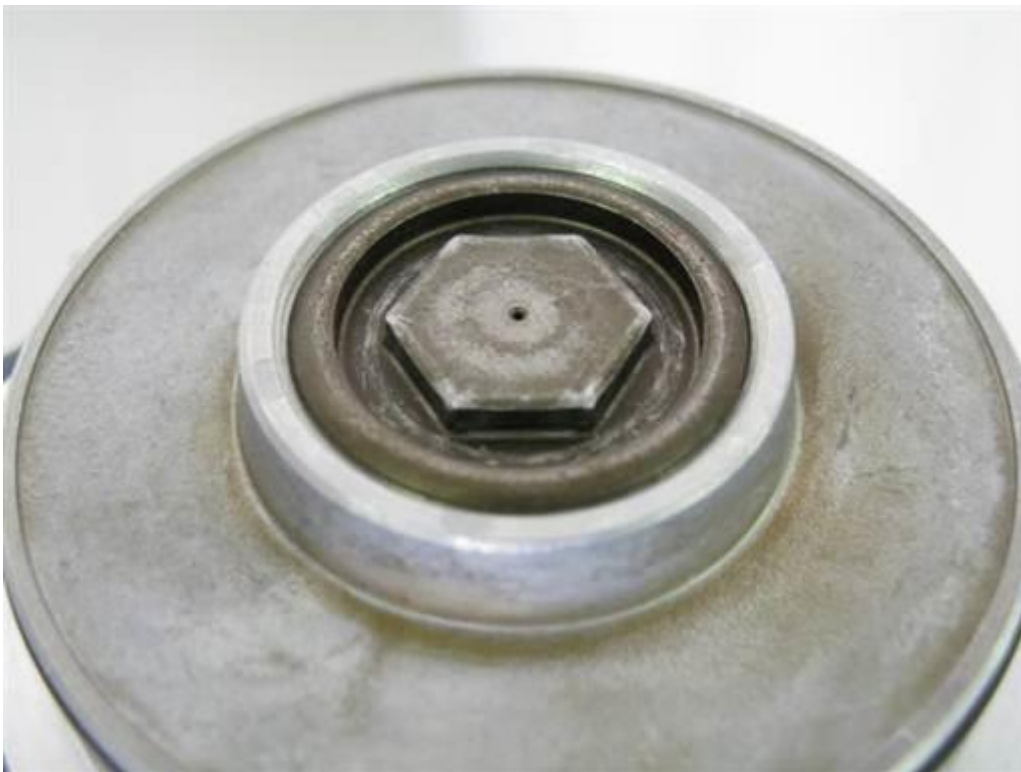
Insert bearing top washer on top of piston bearing ring.
Note: Washer faces are same thus washer can be inserted in either orientation.
Manipulate washer side to side while slightly pressing down to fully insert (fingers).

Install piston bolt/cap.
Counter hold piston and tighten bolt/cap (18mm modified socket 1/2" / hand).
Only hand tighten bolt/cap.
